# Experimental Investigation of Steel Corrosion in Concrete Structures by Acoustic Emission Analysis

Hisham A. Elfergani <sup>1\*</sup>

1 Mechanical Engineering Department- Faculty of Engineering- University of Benghazi.

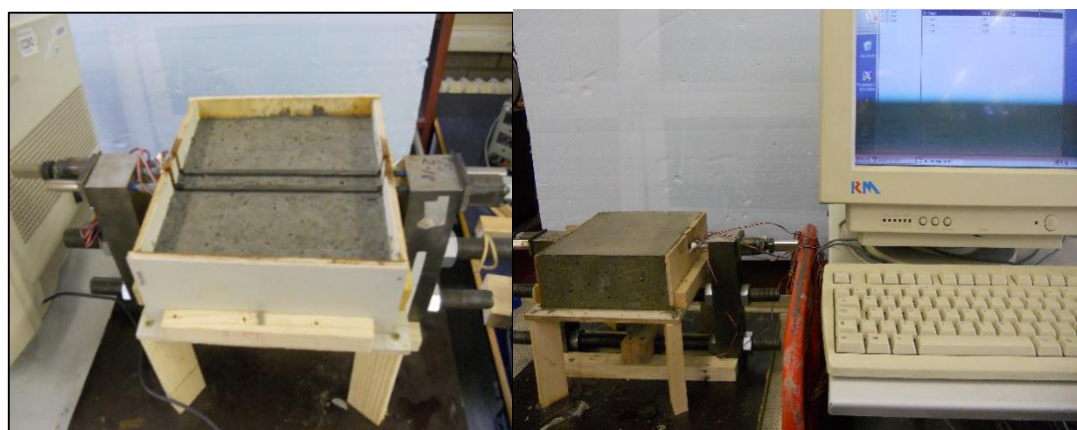
Fig. 3: Concrete and mortar sample

The concrete specimen (200\*200\*50mm), representative of the inner pipe was prepared according to the technical specification for PCCP manufacturing used in the Man-Made River Project, which is in accordance with AWWA C301-92 (Standard for Pre-stressed Concrete Pressure Pipe, Steel Cylinder Type, for Water and Other Liquids) [3]. Three days following the casting of the concrete specimen, the wires, along with their holding frame, were positioned on the upper surface of this specimen. Finally, the mortar 200\*200mm and 20 mm thickness was coated on the upper surface of the concrete. The mortar consists of one part cement to not more than three parts fine aggregate by weight [6, 18, 21]. The final construction is shown in Figure 3.

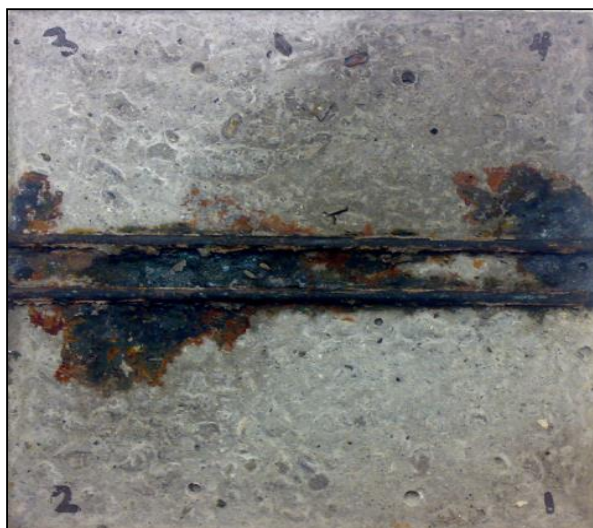
**Fig. 12: Photo of the upper concrete surface and corroded wires**

Figure 12 displays the corroded wires and corrosion products after the mortar has been removed. It is evident that significant corrosion occurred in the upper where a vast majority of AE signals were detected and pinpointed.

Figure 11 illustrates the source locations of signals during this period 2. It can be noted that the highest hits concentration and highest energy in the region coincides with the maximum wire corrosion products area which was visibly observed post-test as shown in Figure 12.

It has been shown that by using AE and the relationship between RA and AF value, the corrosion area can be located and identified (Figures 11 and 12). Hence, it could be possible to provide a corrosion alarm and location to pipe engineers prior to any wire breaks. Furthermore, it is possible to identify the corrosion activity area before the mortar fails to appear.
