Photovoltaic solar cells white Spot Phenomenon in high humidity Coastal: Environmental Factors and Performance Implications

Abstract-

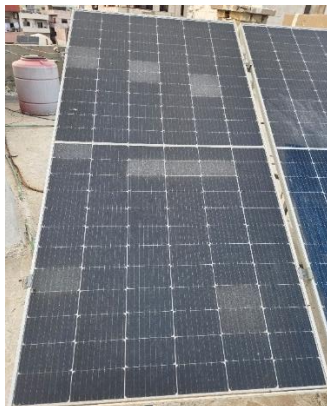
Figure 4: The studied PV solar system at the second measurement number2

The images taken of the studied PV solar system on this day showed that this phenomenon was more widespread and present in a greater number of half-cells during the morning and evening periods. Figure (4,a) shows an image of the panels in the afternoon, just before sunset, clearly demonstrating the increased prevalence of the discoloration phenomenon across a larger number of half-cells. Returning to the temperature readings of the half-cells in Figure (2, c) which had been stained, an increase in temperature was observed since the previous measurement. Temperature measurements were taken on the cells during this period, and the results showed a temperature difference of approximately two degrees Celsius between the colored and uncolored cells.

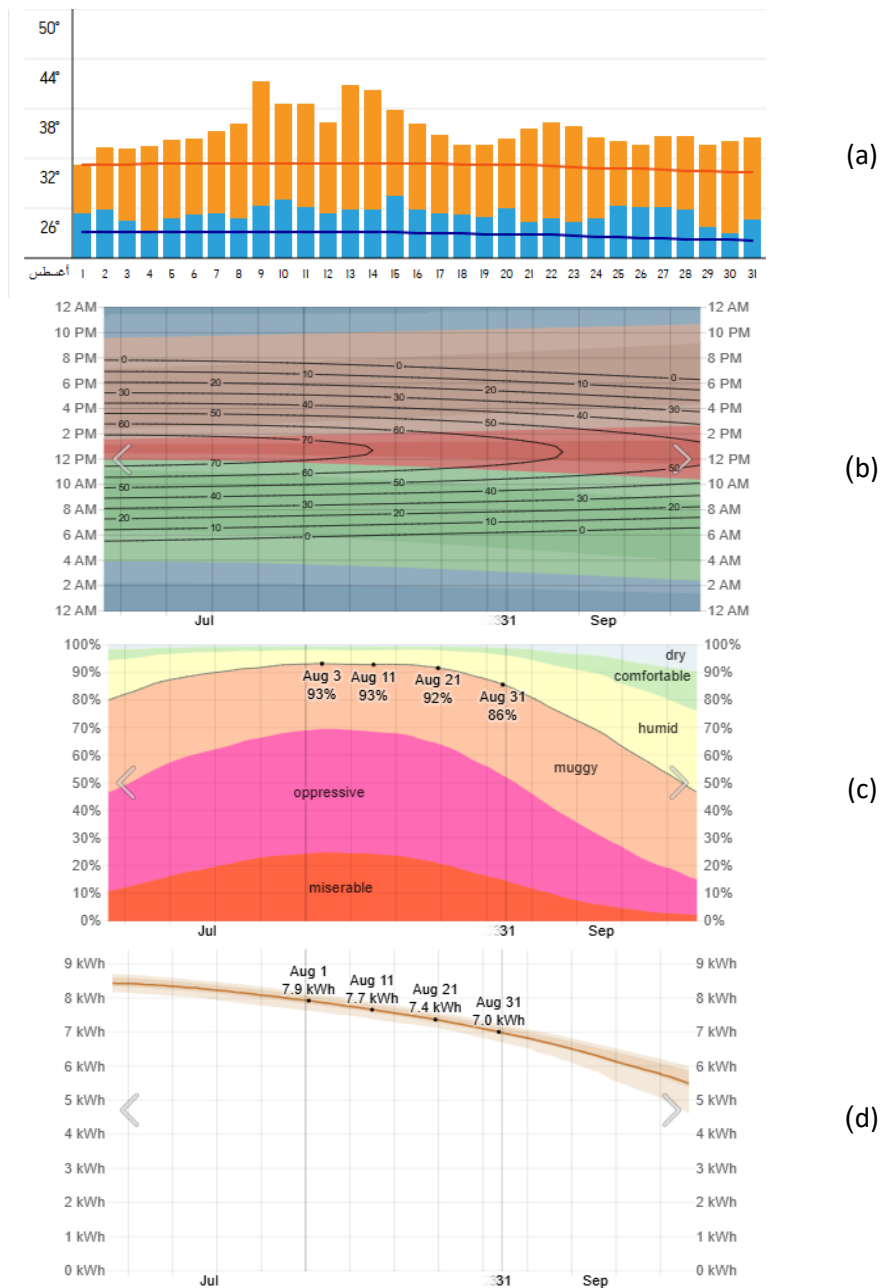
Figure 5: a-Temperature, b-solar elevation & azimuth, c- humidity, d- Average daily incident shortwave solar energy dates in August, Tartus, Syria

Figure (5) shows the temperature, solar elevation and azimuth, humidity, and average daily incident shortwave solar energy data in August.

From Table 1, the measurement day was the 9th of August, and returning to Figure (5), we conclude that the values of temperature, azimuth, humidity, and quantity of shear waves corresponding to the measurement day are as shown in Table 3.

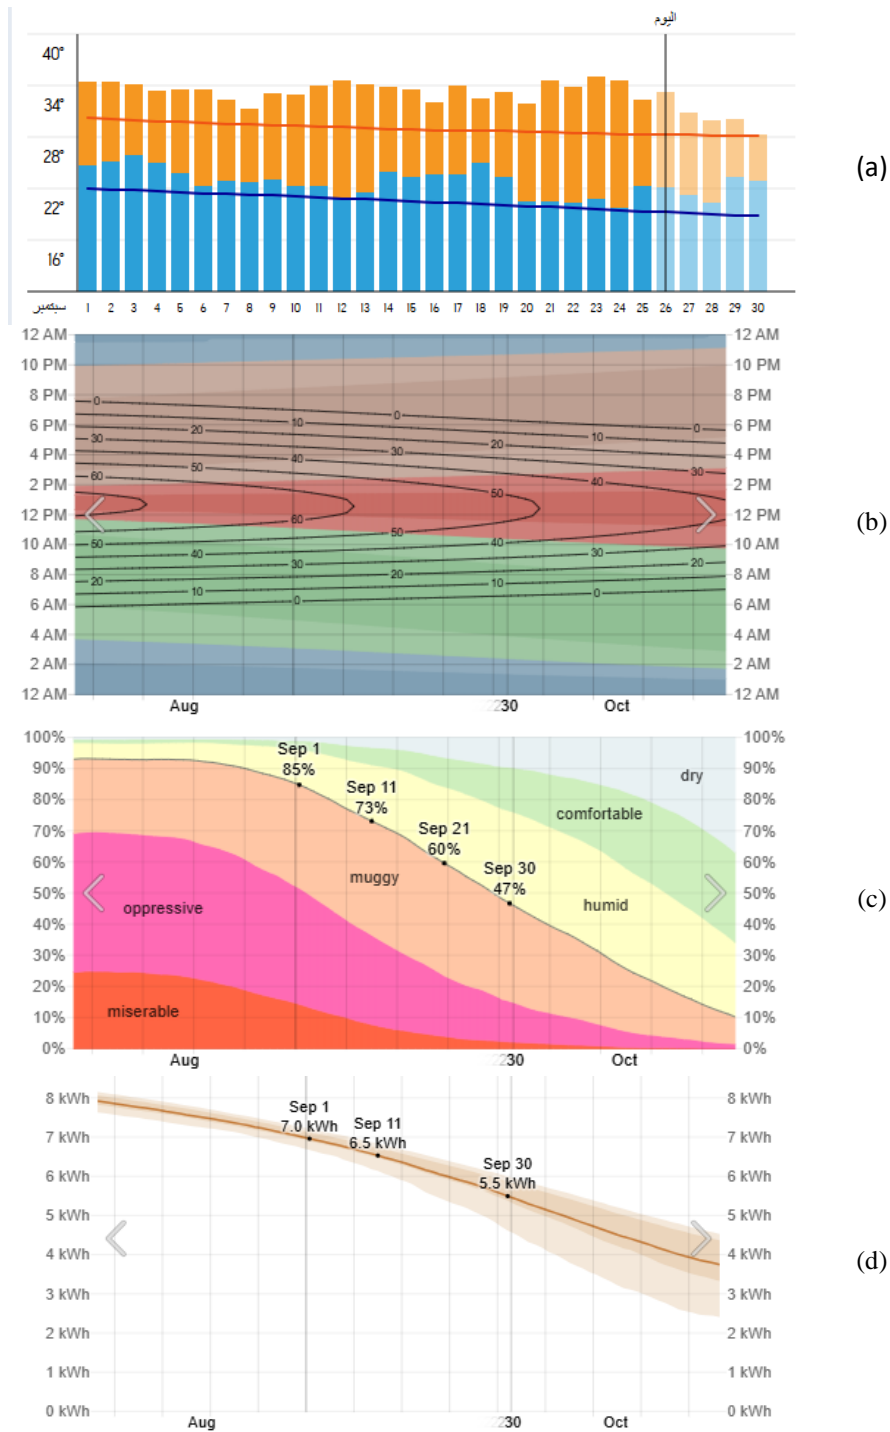
Figure 7: a-Temperature, b-solar elevation & azimuth, c- humidity, d- Average daily incident shortwave solar energy dates in September, Tartus, Syria

Figure (7), shows the temperature, solar elevation & azimuth, humidity and average daily incident shortwave solar energy dates in September.

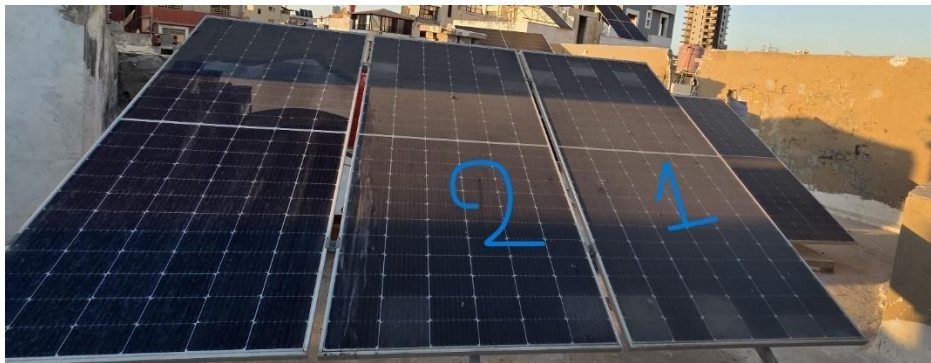
Figure 10 (a,b) The 1.665 kW PV solar system in 13/9/2025

Back to 1.665 kW PV system in 13/9/2025, we noted the increasing in the number of colored cells, as showed in Figure (10, a). We have cleaned the panel number 3, in order

to clear the effect of dust in this phenomenon. Figure (10, b) shows the temperature matrix of panels number 1 and 2.

6	5	4	3	2	1	[2]
						1
						2
						3
28.2	27.9	27.9	27.9		27.9	4
28.8	27.9	27.9	27.9	28.5	27.9	5
28.1	27.9	27.9	27.9	27.9	28.4	6
						7
						8
						9
						10
						11
						12
						1
						2
						3
						4
						5
						6
						7
						8
						9
						10
27.8	28.8	27.8	27.8	27.8	28.5	11
27.8	28.9	28.9	28.9	28.8	29.3	12

6	5	4	3	2	1	[1]
						1
	28.5	29				2
	28.1	28.1	28	29.1	27.9	3
28.7	28	27.9	28	28.2	27.9	4
28.5						5
						6
						7
						8
						9
						10
						11
						12
						1
						2
						3
						4
						5
						6
						7
						8
						9
						10
28.5	28.7	28.1	28	28	28	10
30.3	29.5	29.7	29.3	29.2	29.2	11
30.4	29.8	30.4	29.3	30.4	29.9	12
