# Photovoltaic solar cells white Spot Phenomenon in high humidity Coastal: Environmental Factors and Performance Implications

## Abstract-

This paper presets a "cell spotting" phenomenon that was noticed on the rooftop PV systems along the coast in Tartous, Syria, during the summer, mainly in the early morning and late evening hours under specific environmental conditions. This phenomenon appeared as white spots on the photovoltaic cells. Repeated periodic measurements were taken over four months during the summer, revealing a strong correlation between the appearance of these spots and high humidity levels (above 50%), high temperatures, low direct solar radiation, and dust accumulation. Infrared images were taken of the studied panels during the study period in order to show the temperature deference between the cells with white spots and the other cells in the same panel, and the deference was about 2°C. After cleaning the cleaning the panels, the phenomenon was disappeared. Also, when the sunlight is not direct on the PV panel surface, the phenomenon does not appear. Practical measurements of temperature, humidity, and solar radiation monitoring revealed a strong correlation

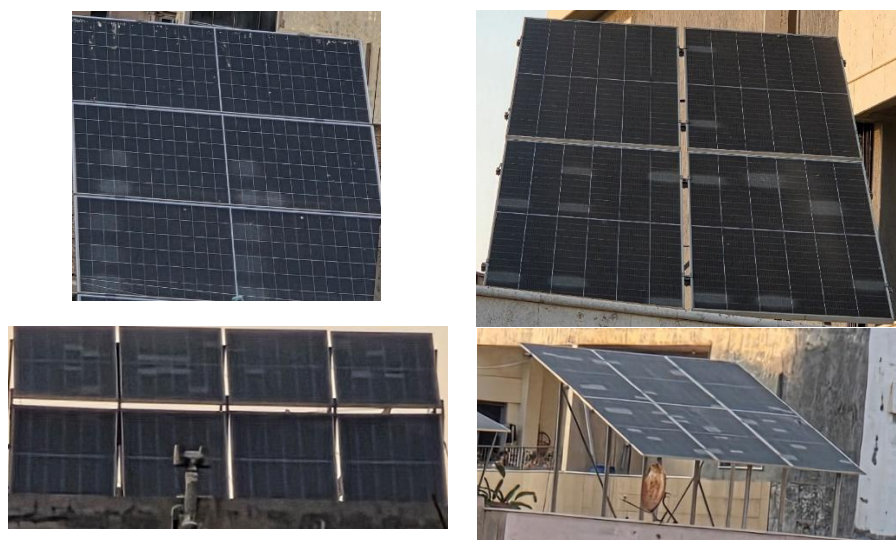
**Figure 3: The phenomenon on other nearby rooftop PV systems**

Figure (3) shows the phenomenon on other nearby rooftop PV systems under the same weather conditions, and this phenomenon was observed to be widespread on them, whether they were half-cell or full-cell panels.

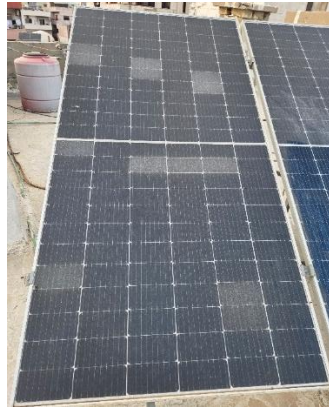
**Figure 4: The studied PV solar system at the second measurement number2**

The images taken of the studied PV solar system on this day showed that this phenomenon was more widespread and present in a greater number of half-cells during the morning and evening periods. Figure (4,a) shows an image of the panels in the afternoon, just before sunset, clearly demonstrating the increased prevalence of the discoloration phenomenon across a larger number of half-cells. Returning to the temperature readings of the half-cells in Figure (2, c) which had been stained, an increase in temperature was observed since the previous measurement. Temperature measurements were taken on the cells during this period, and the results showed a temperature difference of approximately two degrees Celsius between the colored and uncolored cells.

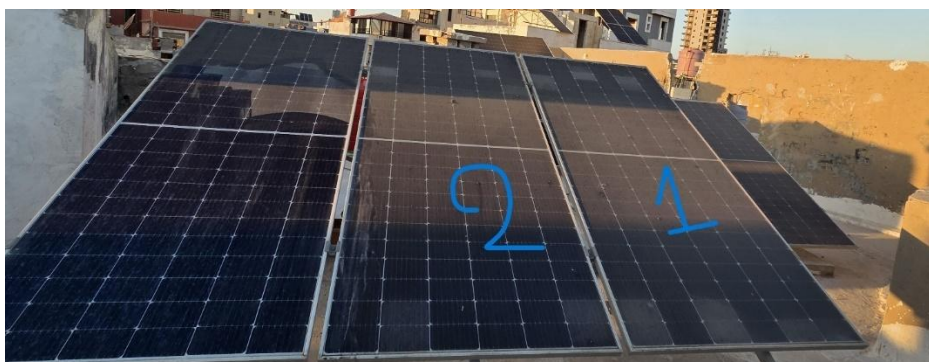
**Figure 10 (a,b) The 1.665 kW PV solar system in 13/9/2025**

Back to 1.665 kW PV system in 13/9/2025, we noted the increasing in the number of colored cells, as showed in Figure (10, a). We have cleaned the panel number 3, in order

to clear the effect of dust in this phenomenon. Figure (10, b) shows the temperature matrix of panels number 1 and 2.
